Testing laboratory for climatic, mechanical
and corrosive environmental stress

QUALITY TEST CERTIFICATE

Test report – No. 19-14770

Impact resistance test – IK07

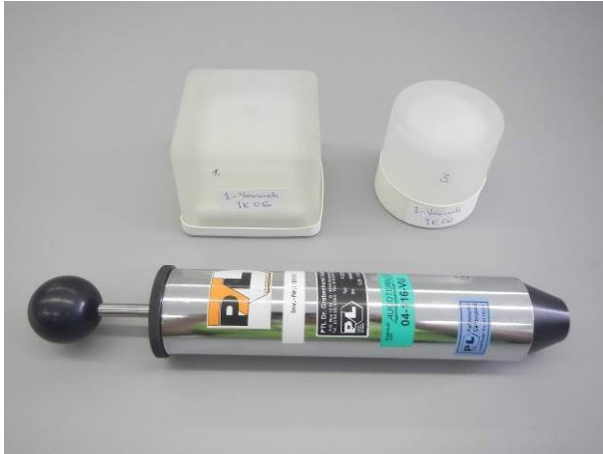
Picture 1
LED cobblestones, samples No.2 and No.4 with spring hammer 0.5 kg | 2 Joule before the impact test IK07

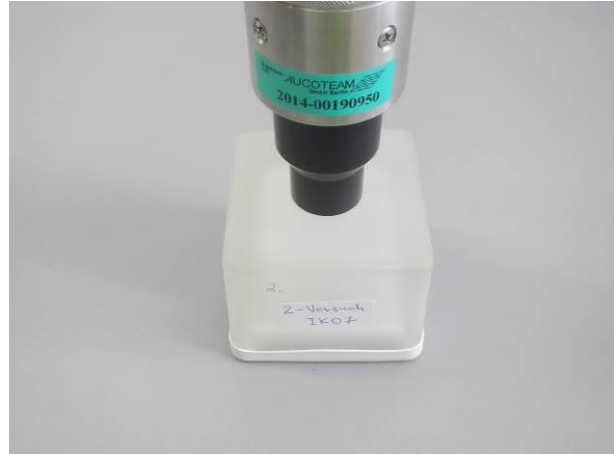
Picture 2
Sample No.2 with spring hammer on the test area during the impact test IK07 (Impact S6)

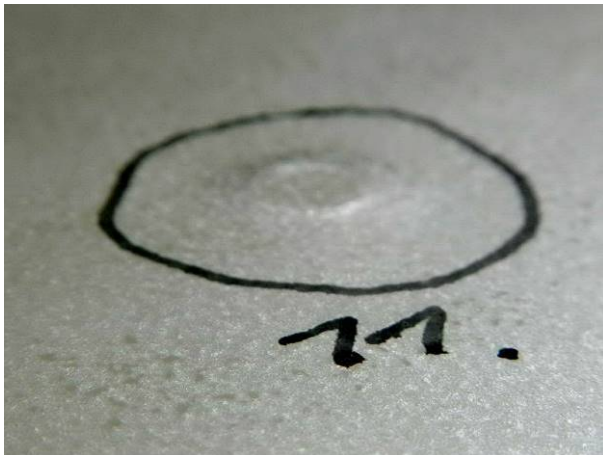
Sample	Impact No. (impact) / impact point results / evaluation
No.2	11. Impact (S11): Top surface, central • Inner material chipped, surface smooth and without cracks. OK

Picture 3
Sample No.2 with visible chip on the material and no cracks on the surface after the impact test IK07 (Impact S11)

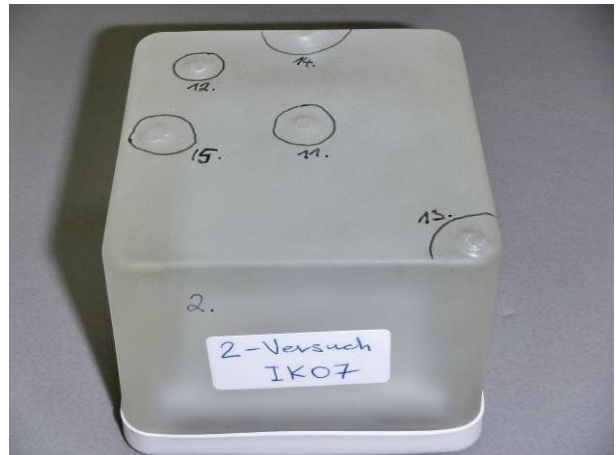
12. Impact (S12): Top surface, top left corner • Inner material chipped, surface smooth and without cracks. OK
	13. Impact (S13): Top surface, bottom right corner • Inner material chipped, surface smooth and without cracks. OK

14. Impact (S14): Top surface, side edge on the top, central • Inner material chipped, surface smooth and without cracks. OK
	15. Impact (S15): Top surface, side edge on the right, central • Inner material chipped, surface smooth and without cracks. OK
No.4	16. Impact (S16): Top surface, central • no visible damage OK

Picture 4
Sample No.2 with visible chips on the material and no cracks on the surface after the impact test IK07 (Impacts S11 – S15)

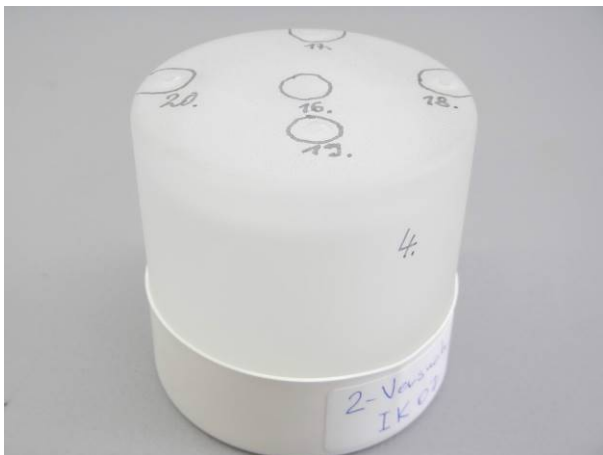
17. Impact (S17): Top surface, side edge on the top • Inner material chipped, surface smooth and without cracks. OK
	18. Impact (S18): Top surface, side edge right • Inner material chipped, surface smooth and without cracks. OK

19. Impact (S19): Top surface, side edge bottom • Inner material chipped, surface smooth and without cracks. OK
	20. Impact (S20): Top surface, side edge left • Inner material chipped, surface smooth and without cracks. OK

Picture 5
Sample No.2 with visible chips on the material and no cracks on the surface after the impact test IK07 (Impacts S16 – S20)

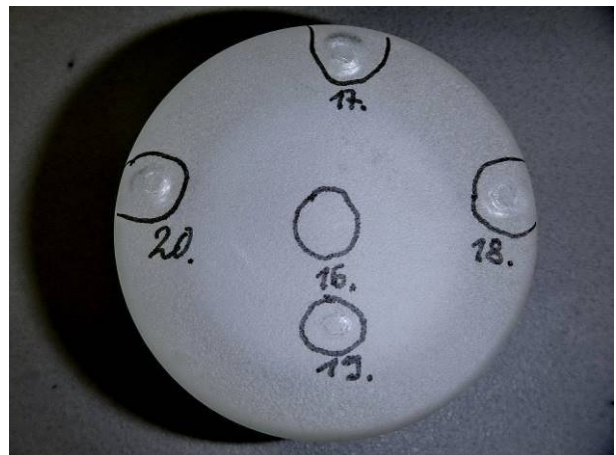
Picture 6
Sample No.2 with visible chips on the material and no cracks on the surface after the impact test IK07 (Impacts S16 – S20)
